**PHASE I ENVIRONMENTAL SITE ASSESSMENT
27 ACRES, 11739 FUERTE FARMS ROAD
EL CAJON, SAN DIEGO COUNTY, CALIFORNIA 92020**

**REYNOLD'S COMMUNITIES
1908 FRIENDSHIP DRIVE, SUITE A
EL CAJON, CALIFORNIA 92020**

W.O. E3521-SC

FEBRUARY 21, 2003

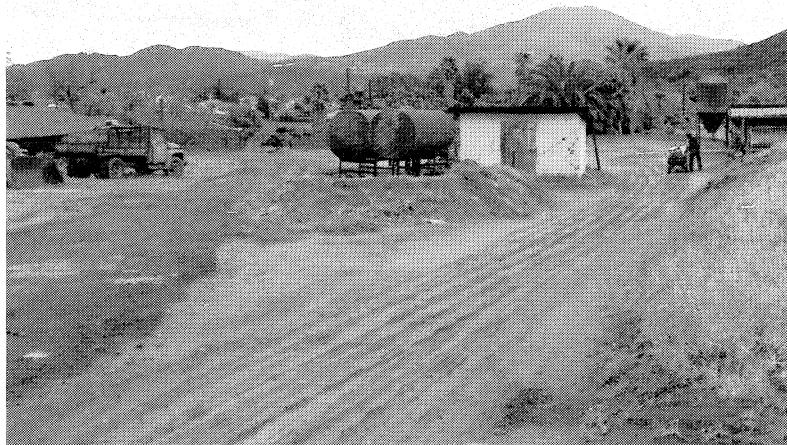
1. Southeastward view near center of property with two ASTs.

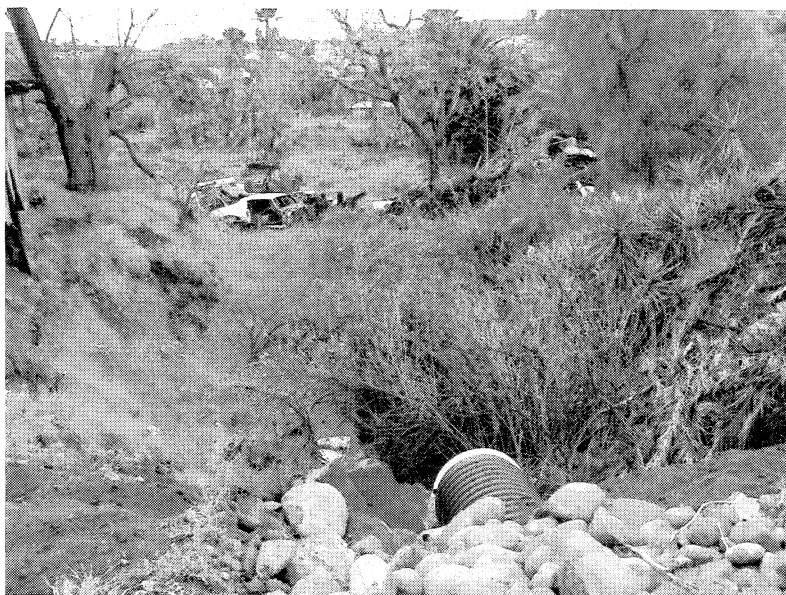
2. Southward view near center of property with stockpiled debris. Note drain in earthen dam in foreground.

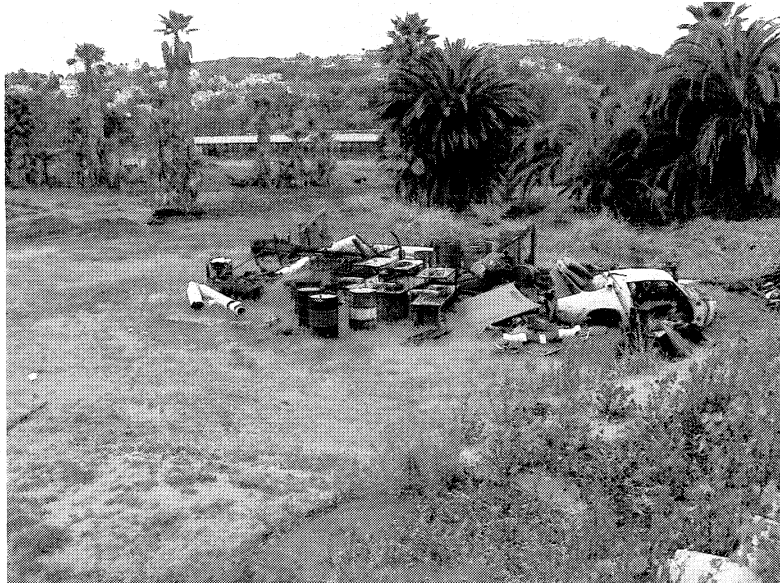
Several debris piles were observed on the property. Debris consisted of wood, metal, abandoned farm equipment, vehicle parts and frames, landscape debris, empty 5-gallon containers, empty 55-gallon drums, etc. Several of the drums contain used oil. No surficial soil staining was observed; however, the piles were not disturbed. There was no visible surficial staining. There does not appear to be significant surficial evidence of onsite hazardous materials/waste and/or petroleum contamination. There was no evidence of underground storage tanks (USTs). Two above ground storage tanks (ASTs) were observed on the subject property. One AST contains gasoline and the other tank contains diesel. The ASTs are maintained in a bermed enclosure. Three water ASTs are located on the property.

3. Southeastward view near center of property with stockpiled debris: 55-gallon drums, vehicle parts, etc.

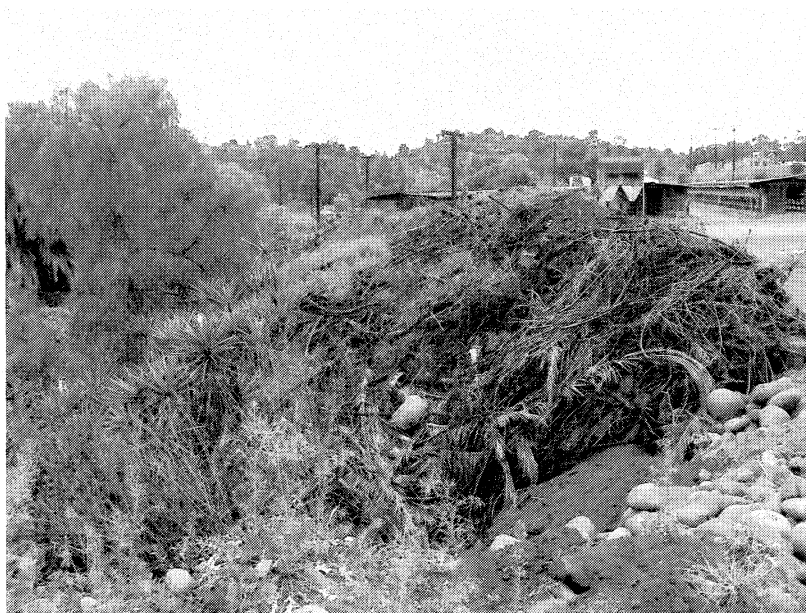
- **Electromagnetic Evaluation** - Overhead distribution lines were observed traversing the property. Evaluation of electric and magnetic fields (EMFs) onsite is beyond this current scope of work.

4. Westward view near center of property with stockpiled debris, mostly landscape debris, and overhead power lines in background.
